Analysis of the Effect of Polyethylene Residues Recycling on Mechanical Performance and Collapse Behaviour in Concrete

Salhin Alaud ^{*1}, Osama Aljrpe¹

¹Civil Engineering Department, Garaboulli Engineering Faculty, Elmergib University, Garaboulli, Libya.

Keywords: Plastic concrete, HDPE, Mechanical performance, Failure behaviour.

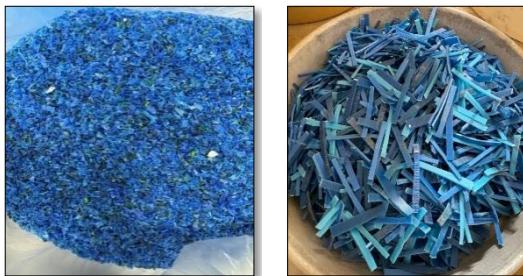
and classified to sizes. The other part was manually cut into fibers with lengths ranging from 38-42 mm, widths from 2-3.5 mm, and thicknesses 1.8 mm. Figure 1 shows the granules and strips of the polyethylene used. A practical program of four concrete mixtures with varying percentages of polyethylene residues served as a basis for the study.

Fig 1. HDPE granules and fibres used in mixes.

CEM I 42,5R regular Portland cement was utilized. Drinking water devoid of biological materials is used for the mixing process. Two types of aggregates were used in this study: marble granular, which is exported from Italy and has a specific weight of 2.63 and an absorption rate of 2.02%, and fine aggregate (sand), which is local and supplied from the city of Misrata with an absorption rate of 0.355%. Both of these aggregates fell within the bounds of the grain gradient curve in the Libyan specifications of fine aggregates (LNCSM49-2002) [7]. Sand made up 60% of the mixing rates for the two types of aggregates, while gravel aggregate made up 40%. The used polyethylene waste was supplied from collection and recycling sites. Part of it was ground into granules, which were then sieved

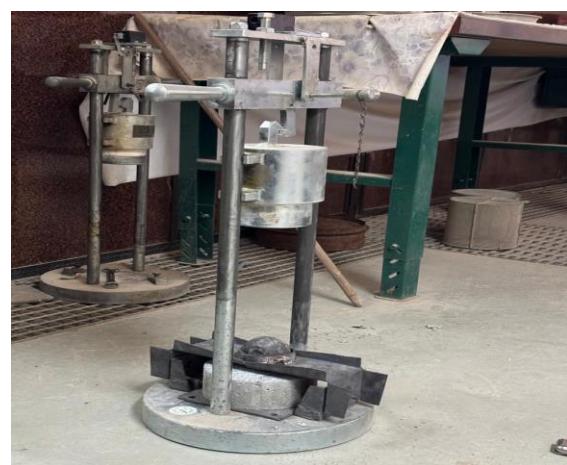
After 28 days, the cylinders for every mix were taken out of the water curing process and dried in preparation for impact testing. A modified aggregate impact testing machine was employed to evaluate the impact of cylindrical concrete specimens. As seen in Figure 2, a steel ball with a diameter of 61 mm was positioned in the middle of the specimen, encircled by a die that applied the impact load vertically while preventing lateral movement. A weight weighing 13.5–14 kg as specified was dropped from 310 mm in height, and the number of blows needed until the first crack showed up, signifying failure, was counted.

Fig 2. Modified Impact Device and Test Sample Preparation: section (upper) and photo (down).

To accurately measure the crack width, a high-resolution image of the surface cracks was captured using a Digi Micro Mobile (dnt) camera with 100×500 magnification and 12-megapixel resolution.

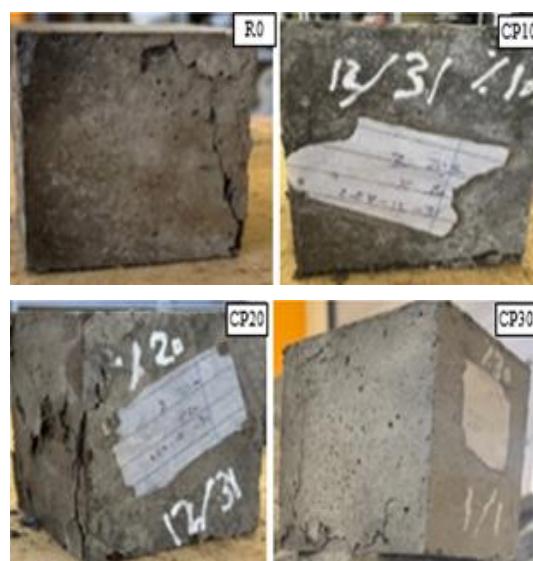
Figure 3 illustrates the failure that occurs when the specimens undergo a compression test after seven days, and Figure 4 illustrates the collapse that occurs after twenty-eight days.

The failure changed from the typical brittle behavior of the reference concrete R0, which had good density and strength, to the concrete that

became "soft" and whose typical brittle behavior decreased when 30% HDPE was substituted.

Fig 3. Collapse pattern of specimens (7-day compression test).

Failure Mode Analysis of Concrete Mixes Based on Time and Mix Type can be compared as a following:

Tests After 7 Days: Mix R0: A clear failure with sharp cracks at one cube corner indicates a typical compressive failure with a cohesive fracture pattern.

Mix CP10: Failure was noted with some splitting and semi-sharp edges. Despite being little weaker than the reference mix (R0), the strength was still within an acceptable range.

Mix CP20: Multiple cracks appeared with wider openings; however, the structural integrity was maintained. This indicates an early sign of weak interfacial bonding due to the addition of HDPE.

Mix CP30: Brittle shear failure was observed, characterized by irregular cracks and non-uniform crack patterns. This mix exhibited the most brittle behavior under loading conditions.

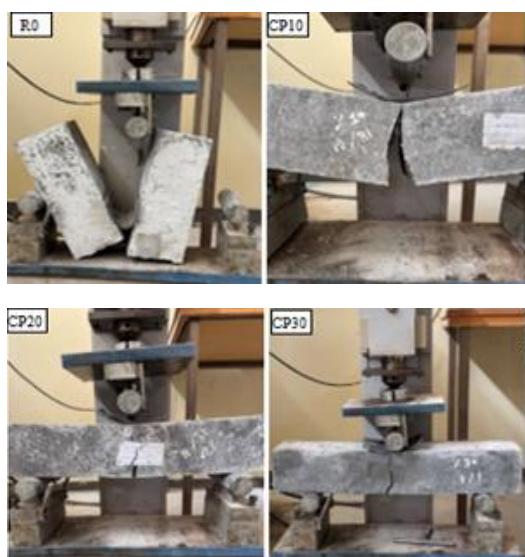
Fig 6. Failure pattern of specimens (Impact test at 28 days).

Impact cracking assessment of the specimen: The theoretical examination of the impact test expresses the crack width and nature of its formation. Figure 6 illustrates the crack patterns resulting from the impact test, resulting from the steel ball's transfer of the free load falling on it, as previously mentioned. From the figure, we notice that the crack pattern in specimen R0 is a sharp, direct radial crack (brittle behavior). In specimen CP10, a clearly distributed crack is located at the center. In specimen CP20, irregular cracks are superficially distributed. Meanwhile, in specimen CP30, there are wide surface cracks, with no obvious bursting. In general, increasing HDPE improves the impact absorption capacity relatively, but reduces the compressive strength and internal cohesion.

By performing a digital crack width analysis, it is found, as shown in Figure 6, that crack widths vary within the same specimen. Crack widths were measured using the aforementioned DNT camera in the widest regions of the crack. In specimen R0, the approximate average crack width is 0.97 mm, with a deep, sharp nature, indicating brittle failure. In specimen CP10, the approximate average is 0.34 mm, with narrower, less extensive cracks, indicating semi-brittle behavior. The approximate average for

specimen CP20 is 1.11 mm, which is the highest in terms of average crack width, indicating the onset of a significant loss of internal bonding, a deterioration in cohesion, and an increase in ductility (semi-ductile). While the CP30 sample shows an average crack width of 0.954 mm, which are relatively distributed and wide cracks, representing ductile failure behavior.
