Axial Compression Behavior of Locally Corroded Slender Circular CFST Columns: An Experimental Study

ABSTRACT

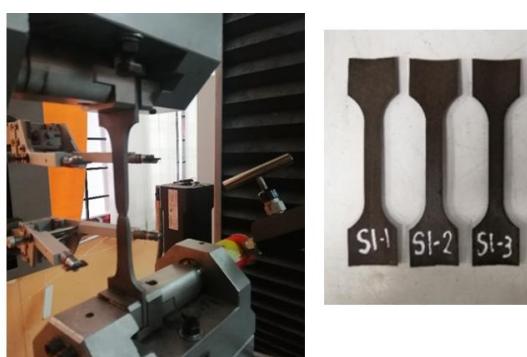
Fig 2. Steel tensile coupon test.

The average modulus of elasticity (E_s) and the yield strength (f_y) of the steel tubes were measured using tensile coupon tests. As illustrated in Figure 2, steel coupons were cut from the tubes according to ASTM-E8/E8M [14]. These coupons were subjected to axial tensile loadings on a Universal Testing Machine with a capacity of 100KN (Figure 2). The resulting stress-strain curves of the steel are presented in Figure 3. Additionally, Table 2 shows the average results from the steel coupon testing. As illustrated, the average test yield strengths of the steel were measured as 292 MPa.

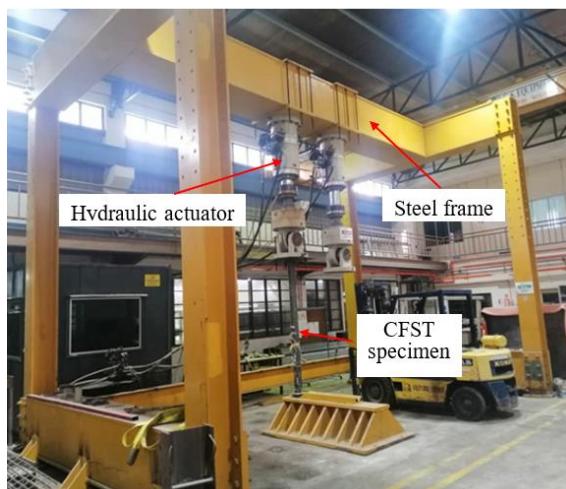
Fig. 5. The utilized loading frame systems to test the long CFST columns.

Materials Laboratory at Universiti Kebangsaan Malaysia (UKM). As shown in Figure 5, the loading frame consists of four steel columns and three girders. An actuator having a maximum capacity of 1000 KN and with a displacement loading control system was utilized. The applied load was measured using a load cell attached to the top girders. The details of the test instrumentation and setup of long columns are illustrated in Figure 6

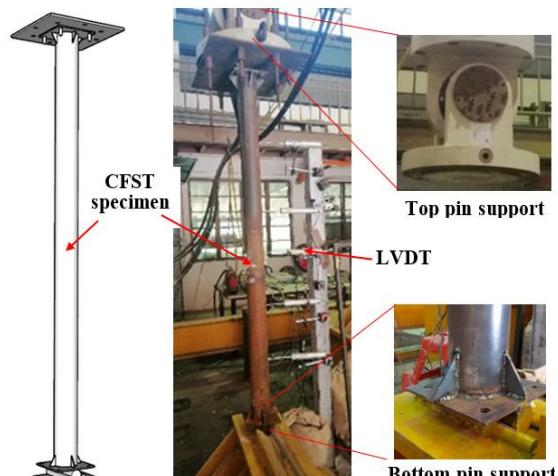
Fig 6. Test setup of the CFST Long columns.

Hinge-hinge boundary conditions were adopted using the built-in top swivels and the fabricated pin support using cylindrical rollers at the bottom of the columns. The supports shown in Figure 7 were to simulate pinned-end circumstances by allowing free rotations around the main axis while restricting rotations around the orthogonal axis. In addition, two end plates with four vertical stiffeners were welded to the top and bottom of the columns. Five LVDTs were mounted on the side of the specimens to measure the horizontal displacement at equally spaced positions, along with the height of the specimens during the loading process. In addition, two strain gauges were attached to the mid-height of the long columns in both the axial and the lateral directions

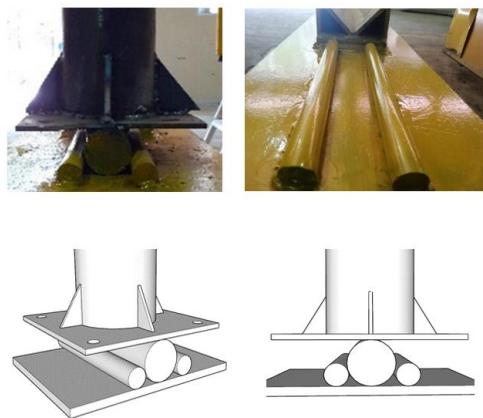
Fig 7. Fabrication of the bottom hinge support of the long columns.
