Relationship between Horizontal Bedding and Joints Affecting Rocks Slopes Parallel to Al-Rujban Mountain Road, Libya

Aboalgasem Alakhdar

Geological Engineering Department, Faculty of Engineering Jadu, Nalut University, Jadu, Libya.

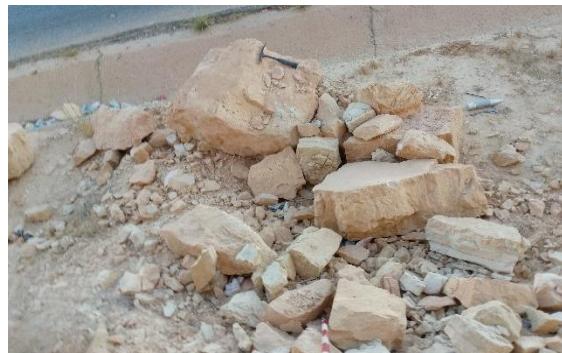
The evaluation of slope stability represents a fundamental aspect of geomechanical analysis. It is often expressed by the angle of repose, which defines the maximum inclination at which rock or unconsolidated materials can remain stable without undergoing failure or collapse [12]. Field observations at the slope site revealed that the rock masses are extensively affected by fractures and cracks exhibiting variations in orientation and dip angle. Distinct stratigraphic planes were identified, differing in their thickness, lateral continuity, and the nature of the materials filling the discontinuities. Evidence of a rockfall-type failure was observed, involving blocks of various sizes and shapes that had detached and accumulated approximately two meters from the roadside Fig 1.

Fig 1. Rockfall at the study site.

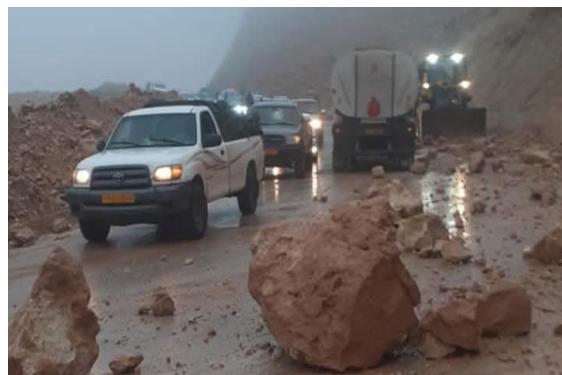
It is important to note that the Rujban Mountain road is occasionally affected by Rockfall, particularly during periods of intense rainfall or after prolonged weathering processes Fig 2. Reference [13] pointed out that a rock debris collapse occurred in December 2023, indicating the ongoing instability of the slope in that area.

Fig 2. Rockfall at the Rujban Mountain Road.

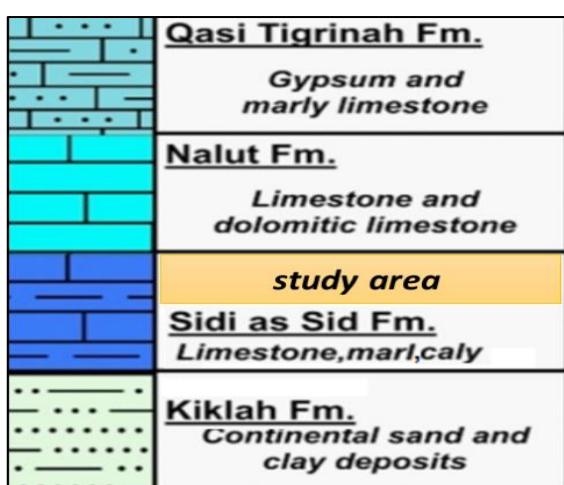
The Jebel Rujban Uplift and its mountainous road are part of the Nafusa Uplift, which extends from southeastern Tunisia to northwestern Libya, spanning approximately 400 km [13]. The main formations along the adjacent slopes include, from bottom to top, the Kiklah Formation, the Sidi As Sid Formation, and the Nalut Formation Fig 4, capped by the Upper Cretaceous Tigrinah Formation

Fig 4. Stratigraphic columnar section.

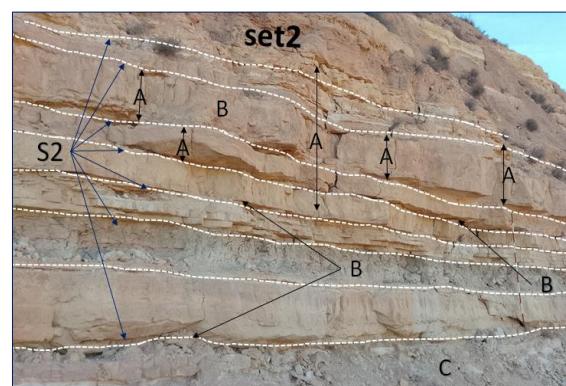
Fig (4) of the Road Cut rock (Set 2) shows a distinct sequence of beddingPlanes with horizontal to sub-horizontal orientations. These levels represent natural bedding planes that separate the sedimentary layers. According to Table (6), approximately twenty bedding levels were identified, indicating a clear repetition of horizontal discontinuities within the rock section. The bedding layers vary in thickness and lateral continuity, reflecting differences in depositional conditions and the succession of sedimentary environments.

Fig 4. Road Cut rock- Ain Tobi Member.

However, the presence of horizontal joints (bedding planes) forms potential weak surfaces, particularly on steep slopes (85°–90°), increasing the likelihood of rockfalls under vibrations or basal erosion Fig 4 The occurrence of clay seams between bedding planes further facilitates collapse and slope weakening. These planes exhibit rough textures and narrow separations (10–20 mm), which reduce water permeability and enhance shear resistance. Nevertheless, prolonged weathering and erosion processes may gradually widen these openings and increase the potential for surface failure.

Overall, the bedding planes in this exposure act as major horizontal structural discontinuities that control rock disintegration and block distribution. They represent the most influential structural element governing the geomechanical behavior of the rock slope.

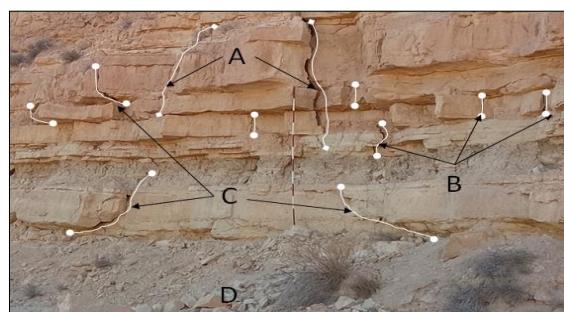
Fig 5 shows a series of discontinuous and irregular vertical joints (A–B–C) that penetrate the horizontal bedding planes shown in the previous Fig. These fractures do not follow a specific structural trend but are randomly and irregularly distributed within the rock masses, indicating that they developed after the formation of the bedding planes, most likely as a result of tensile stresses or blasting activities associated with the construction of the Rayayna mountain road. The horizontal bedding planes represent the original sedimentary structure within the outcrop, formed through successive depositional stages. Over time, due to mechanical stress or surface erosion, vertical fractures developed that penetrated these horizontal planes without disturbing their arrangement, confirming their nature as secondary structural features. These vertical joints intersect the bedding surfaces at nearly right angles, forming a network of intersecting fractures. However, they do not constitute a well-defined

**Fig 5.** Ain Tobi Member Random fractures.

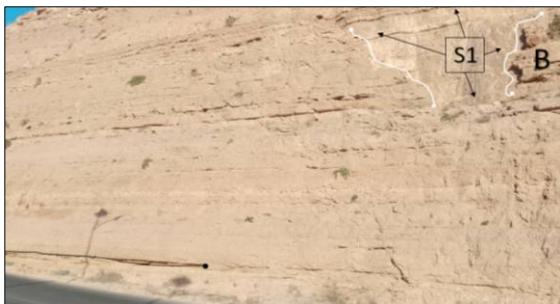
Fig 6 shows that Road Cut rock- Ain Tobi Member without bedding planes do not exhibit random fractures or joints. It can also be observed that the presence of a plane parallel to the slope face (Set 1) is responsible for the detachment of rock blocks along the slope, indicating that this structural feature controls the separation of blocks parallel to the slope face.

Fig 6. Road Cut - without bedding planes.

It is worth noting that some bedding planes are extremely close, with separations of up to 10 mm, forming thin lamina units that are not clearly visible in the Fig 6.
